# Manhole Inspection Summary

Manhole # S41C\_\_054MH

Insp Date: **12/23/08 8:51 AM**

**Location** Address: **1241 orleans st**

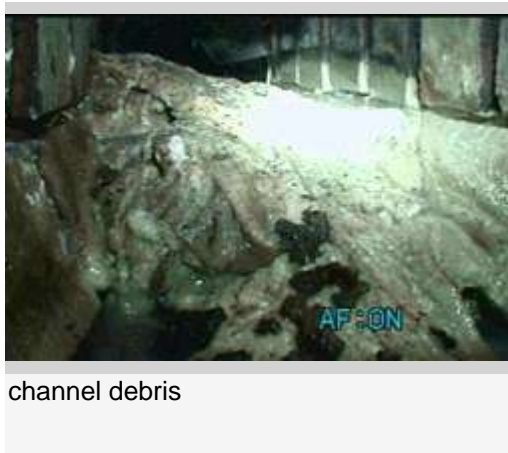
Defect 3

Condition: ☐ Sound ☐ Cracked ☐ Root Intrusion ☐ Deteriorated ☐ Leaks ☒ **Debris**

channel debris

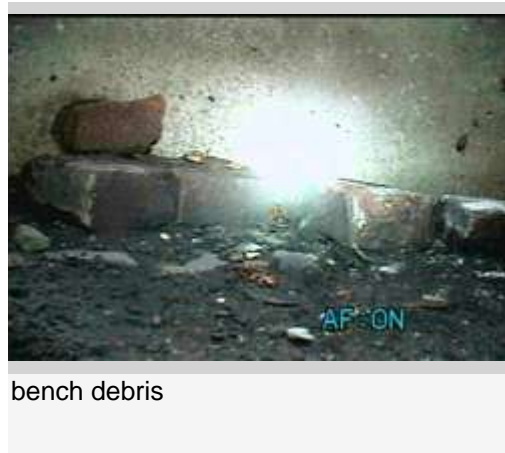
Defect 2

Condition: ☐ Sound ☐ Cracked ☐ Root Intrusion ☐ Deteriorated ☐ Leaks ☒ **Debris**

bench debris

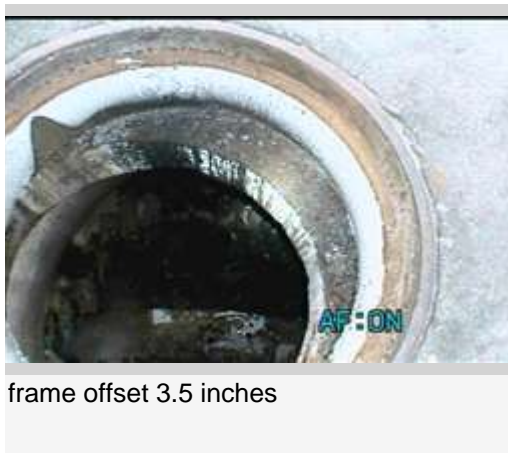
Defect 1

**Frame** Offset: **3.5** (in.) Condition: ☒ Sound ☐ Cracked ☐ Leaks

frame offset 3.5 inches

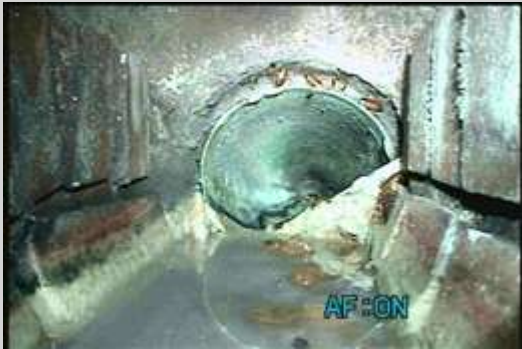
12 O'Clock Outflow

8 in. Circular Gravity Sewer  
Pipe Out @ 12 O'Clock

Pipe Material: PVC ☐ Pipe Lined

Invert Depth: 4.13 (ft.) Flow Characteristics: Slow

Deposits: ☒ None ☐ Mud ☐ Sludge ☐ Debris ☐ Grease

Infiltration: None

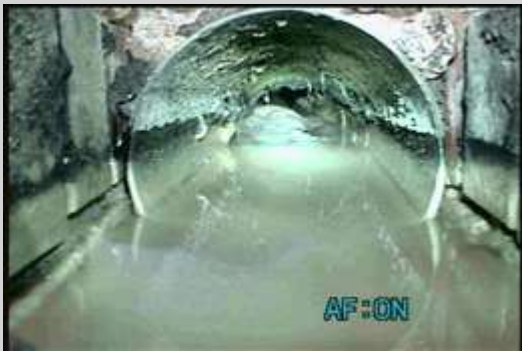
5 O'Clock Inflow

8 in. Circular Gravity Sewer  
Pipe In @ 5 O'Clock

Pipe Material: Clay ☐ Pipe Lined

Invert Depth: 4.00 (ft.) Flow Characteristics: Slow

Deposits: ☒ None ☐ Mud ☐ Sludge ☐ Debris ☐ Grease

Infiltration: None
